# Annual Dane County Yahara WINS Adaptive Management Report

Annual report on Dane County Land & Water Resources Department efforts assisting with the implementation of conservation practices that reduce phosphorus runoff for the Yahara WINS Adaptive Management project.

**2018 Report Yea**

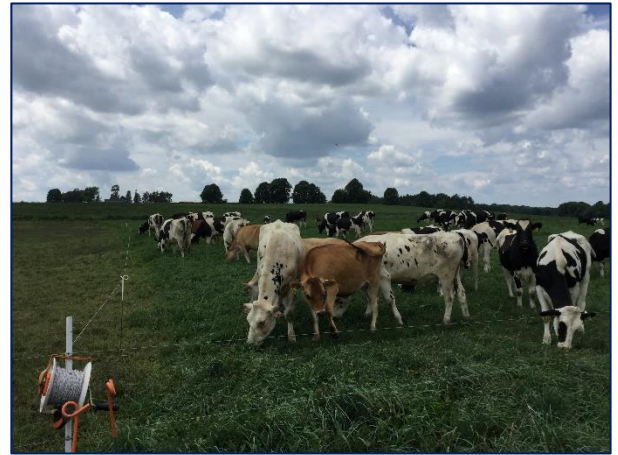
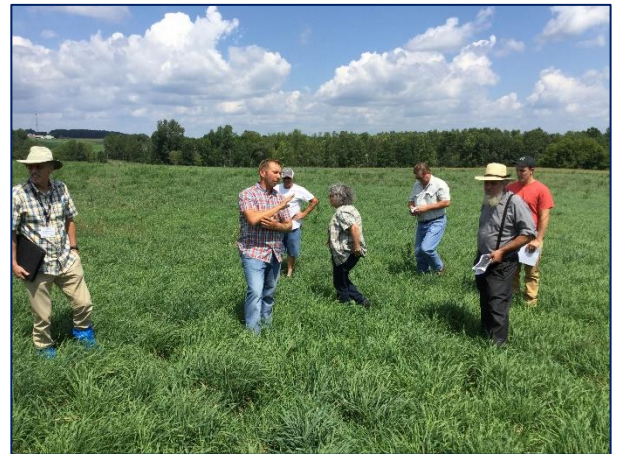
Temporary fencing installed in a managed grazing system (top photo). Landowners discussing solutions for managed grazing systems (bottom photo).

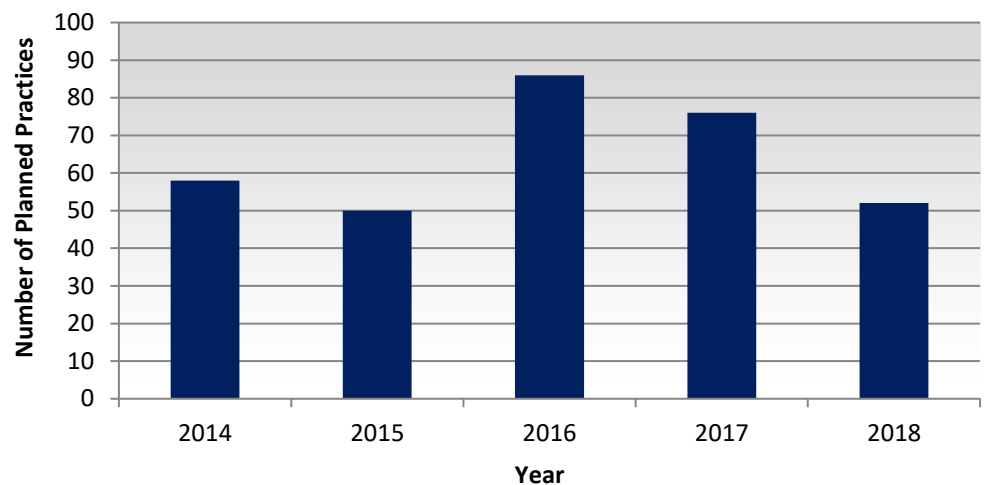
FIGURE 1.

Number of planned conservation practices within the Yahara watershed identified in the Dane County annual work plans submitted to Yahara WINS.

More than 50 conservation practices in the Yahara watershed received planning assistance from Dane County in 2018 (Figure 1). Many of these planned practices were successfully implemented this past year (see [Practices Implemented](#)). Practices that were not completed continue to receive planning assistance with the intention of being implemented in 2019 and beyond. The implementation of conservation practices by a landowner or producer is voluntary and the number of planned practices versus implemented practices varies each year.

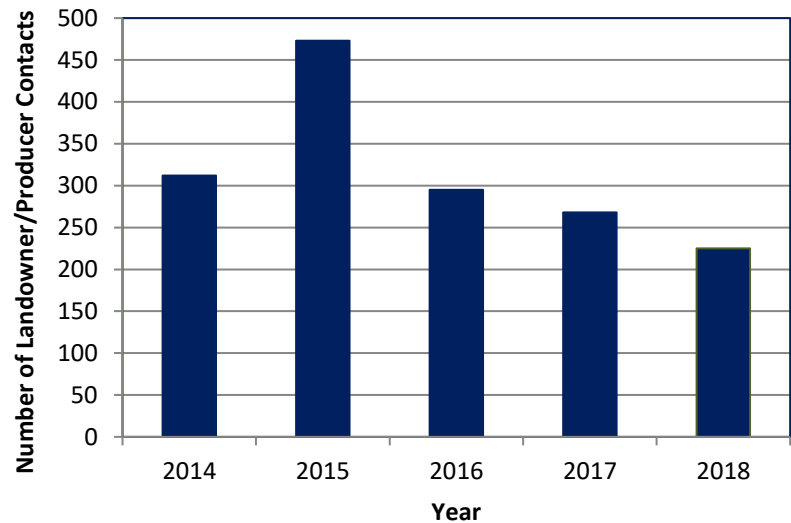
FIGURE 2.

Number of annual landowner/producer contacts since 2014.

In 2018, Dane County contacted 225 landowners and producers within the Yahara watershed (Figure 2). Services provided include but are not limited to; identifying resource concerns, providing technical and financial assistance for conservation implementation, and verifying compliance with program participation, rules, and ordinances. These contacts are critical for practice implementation as they are often the first steps in establishing productive relationships between the landowner or producer and county staff.

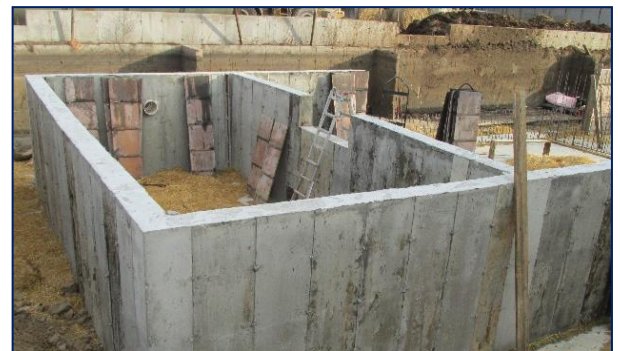
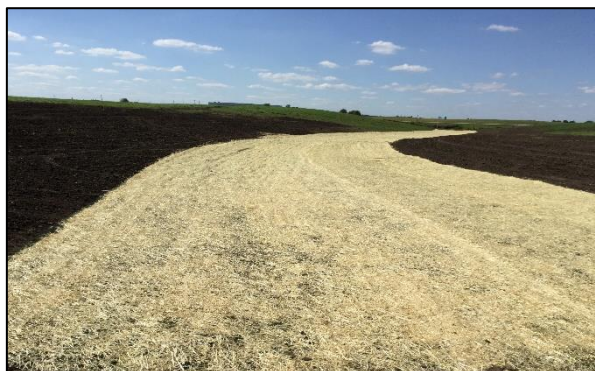
Installation of a waste transfer system (top photo) and grassed waterway (left photo).

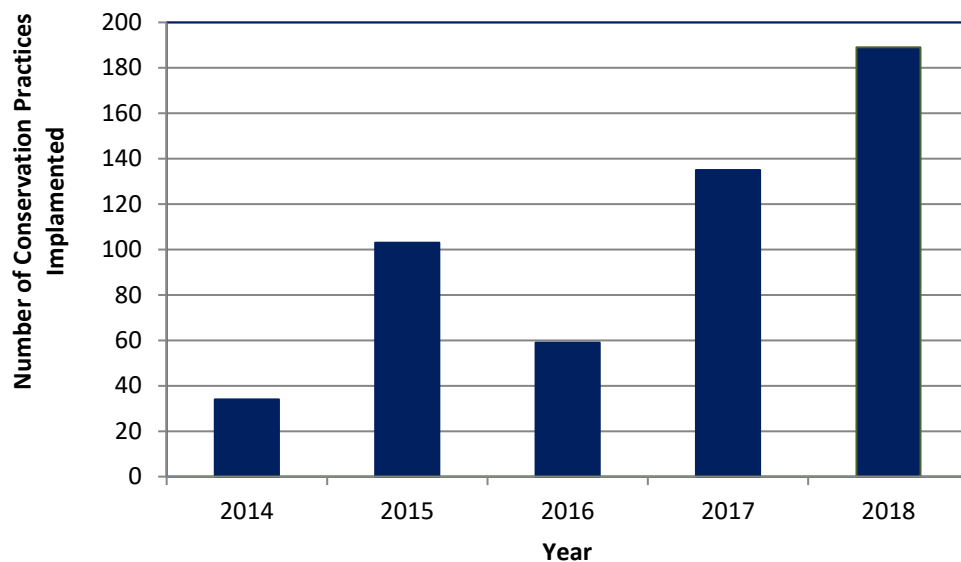
**FIGURE 3.**

Number of conservation practices implemented in the Yahara watershed since 2014.

2018 was a challenging year for conservation practice implementation. Large amounts of rain and flooding in August reduced the amount of time for practice implementation. However, even with the unfavorable weather conditions staff were able to assist landowners and producers in completing 40 different projects resulting in 189 individual conservation practices being implemented (Figure 3.). This is a 40% increase from 2017. Conservation practices implemented by landowners and producers this past year included cover crops, conservation cover, waste storage structures, grassed waterways, sediment basins, and harvestable buffers (Table 1). Since 2008, staff have assisted with implementation and tracking more than 630 conservation practices within the Yahara watershed (Figure 4.).

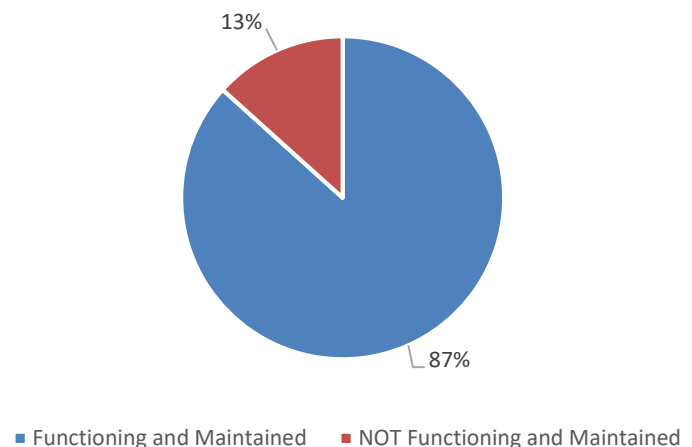
FIGURE 5.

Field verification and review of conservation practices.

In total, 15 previously implemented conservation practices were checked in 2018 to verify their continued function, maintenance, and associated phosphorus reductions. Practices in TMDL reaches 62, 64, 65, 66, and 68 were selected as part of a larger, countywide, practice and compliance review process outlined in *Madison Metropolitan Sewerage District Adaptive Management Plan* under Agricultural Implementation Strategy. All remaining practices will be included in this review process within the next two years, and continue through the life of the project on a four year rotation. Of the 15 conservation practices checked, 12 were found to be functioning and maintained, three were identified as not functioning and maintained (Figure 5).

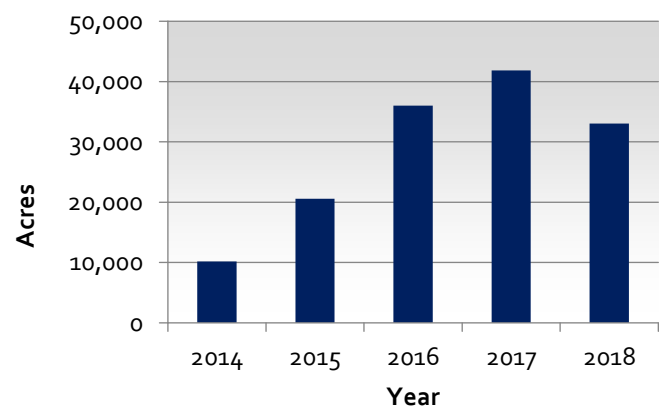
FIGURE 6.

Total acres of nutrient management plans mapped within the Yahara watershed since 2014. Internally drained areas have been removed.

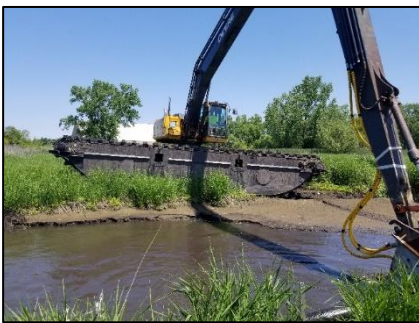
Photo of the hydraulic dredge removing legacy sediments from Dorn Creek.

This past year was the first year in which a “full scale” removal project was implemented. Approximately 11,000 tons of phosphorus laden sediment was hydraulically removed from a 2.7 mile stretch of Dorn Creek. Additional sediment samples were also collected, analyzed, and evaluated to determine the feasibility of removing sediments from other stream reaches within the Yahara watershed. As a result, Token Creek was selected as the second site with plans to be begin sediment removal in July of 2019. More information regarding the Legacy Sediment Removal Project can be found here: <https://lwr.dane-county.gov/legacy-sediment-project>.

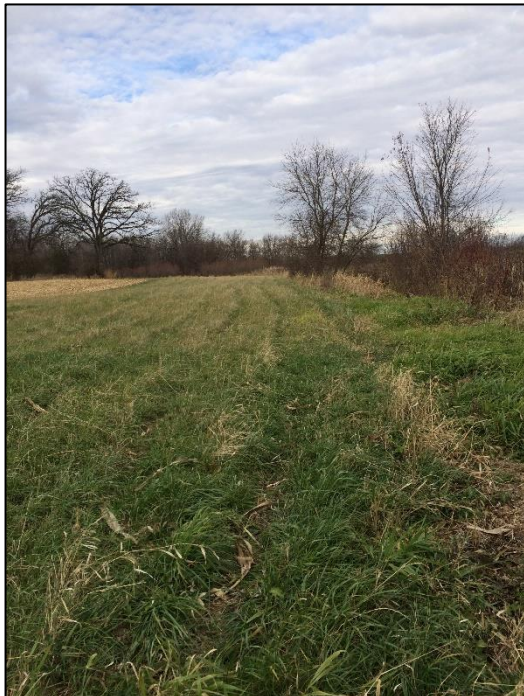
Photo of an established harvestable buffer.

Harvestable buffers continued to be a popular conservation practice. These buffers typically consist of a combination of cool season grasses and legumes and are established along perennial streams with a minimum width of 30 feet. The purpose of the buffer is to filter and trap phosphorus and sediment laden runoff before it enters the stream. More than 31 additional acres were established bringing the total acres implemented since 2014 to more than 132 (Table 3). This equates to approximately 24 miles of buffered streams.

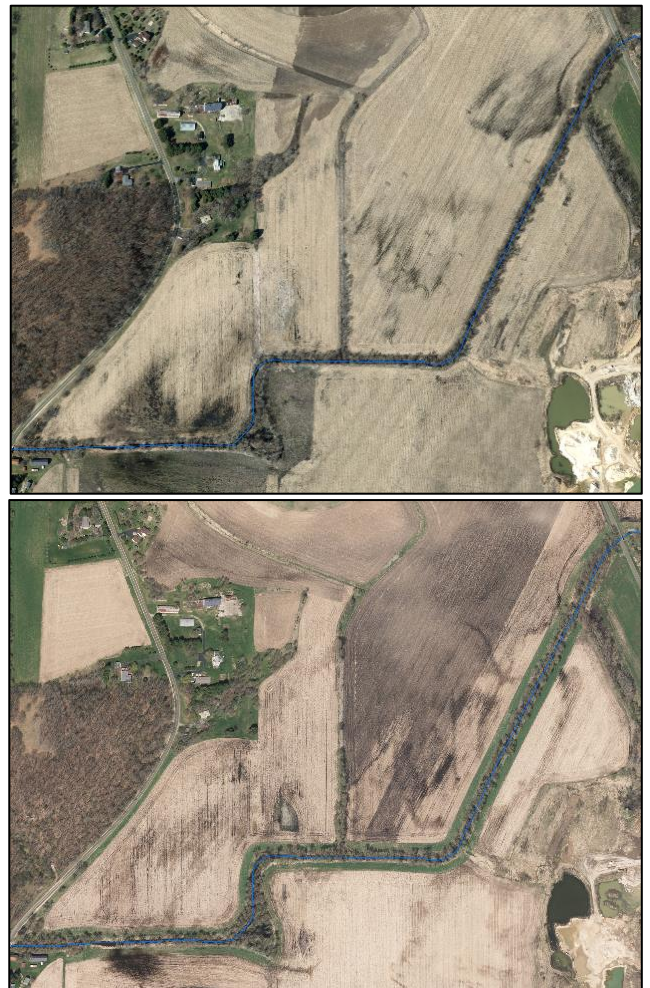
Aerial photos of Little Door Creek before (top) and after (bottom) the implementation of harvestable buffers.

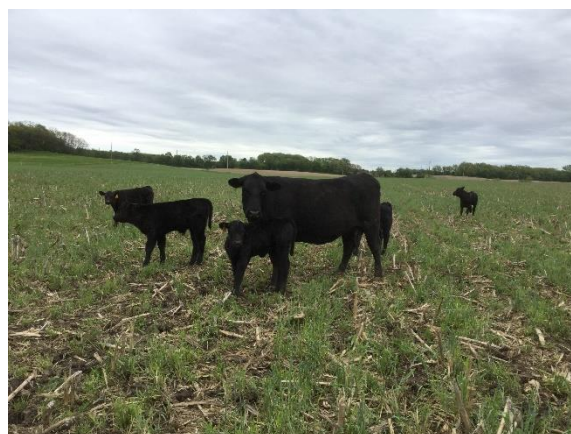
Photo of livestock grazing cover crops.

An innovative approach of using cover crops for grazing livestock was also implemented by producers within the Yahara watershed this past year. Producers worked with staff to identify cover crop types that not only protect the ground from soil erosion and phosphorus runoff during the most critical time periods during the year (winter and spring), but that also provide a quality food source for grazing livestock adding financial value to their operations. Seeds were planted and vegetation was established in September of 2018. As temperatures rose and the snow melted the cover crops continued growing providing not only continued ground cover but also a quality food source for grazing livestock early on in the growing season.

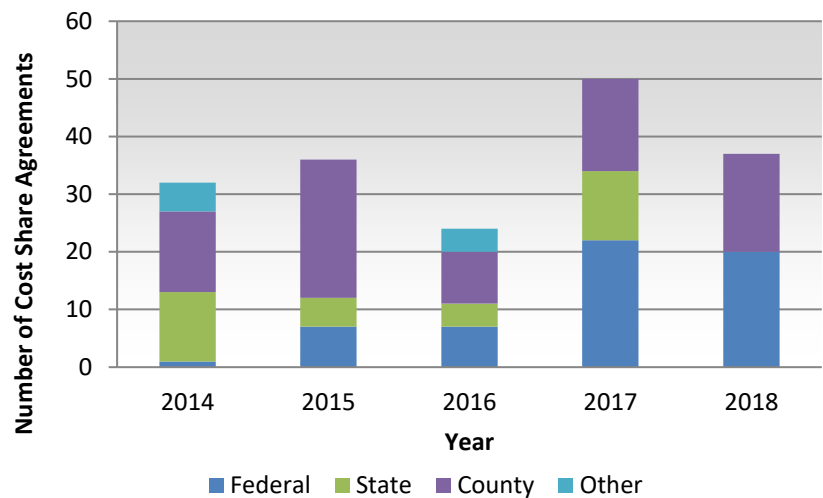
**FIGURE 9.**

Number of cost-share agreements by funding source entered into each year within the Yahara watershed since 2014.

utilized federal, state, and county, funding sources (Figure 8) within the Yahara. Other funding sources were not available nor utilized in 2018. The total cost-share funding allocated in 2018 was over \$835,000 (Figure 9).

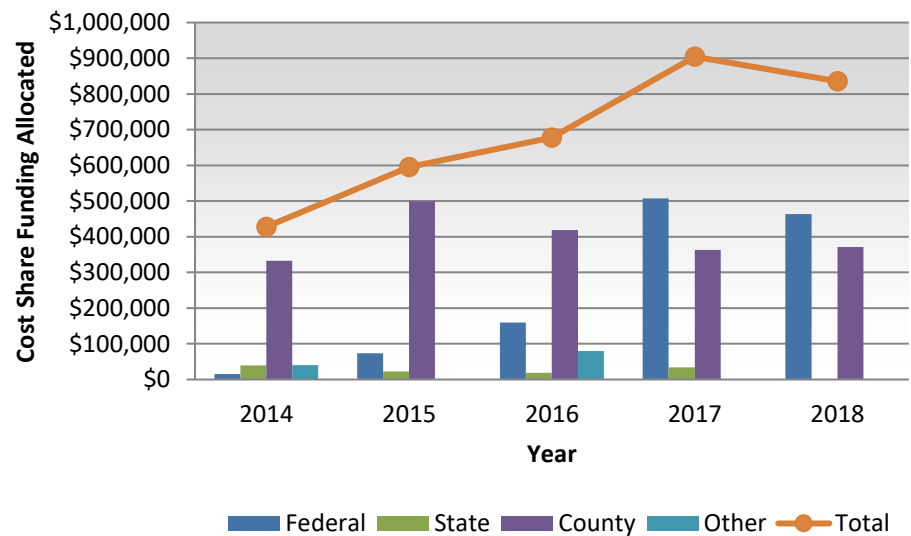
**FIGURE 10.**

Total cost-share dollars allocated by funding source each year within the Yahara watershed since 2014. The cumulative total from all funding sources is also presented.

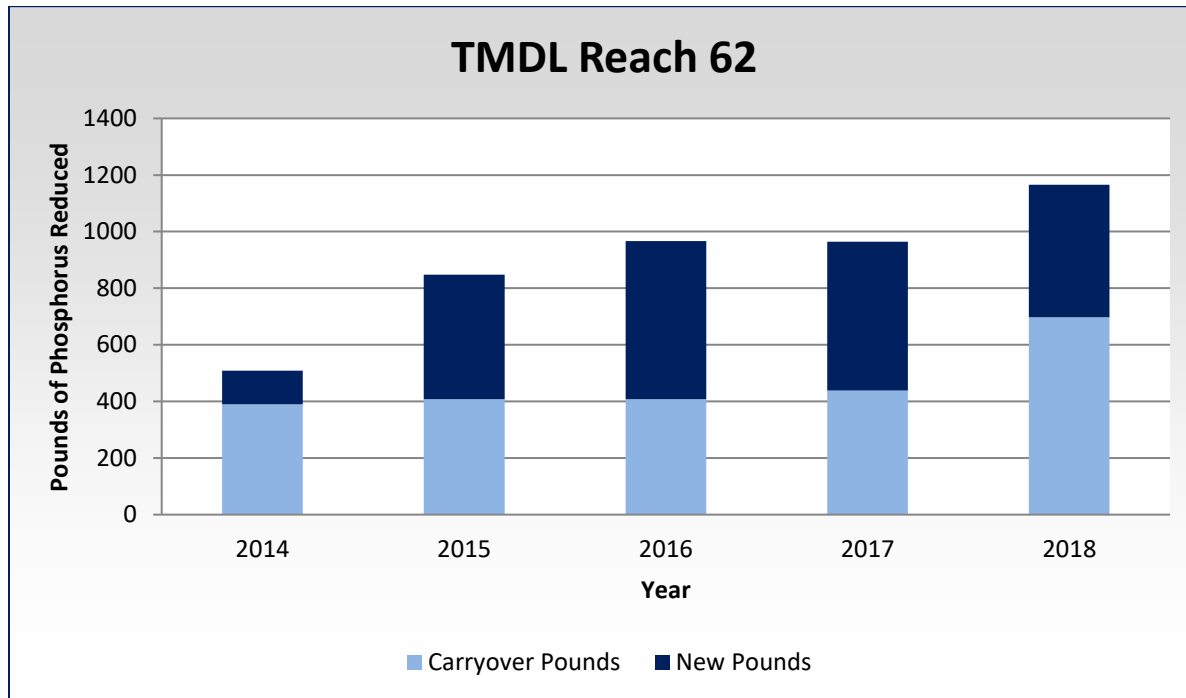
FIGURE 11.1.

TMDL Reach 62 new and carryover pounds of phosphorus reductions by year.

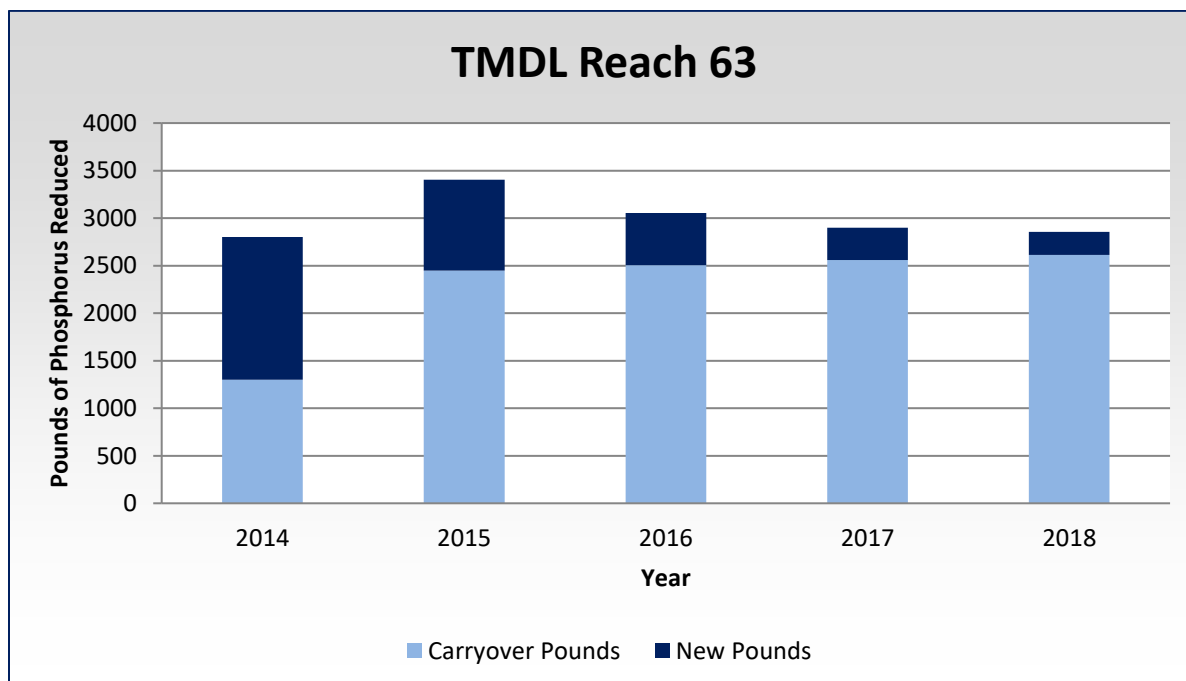
FIGURE 11.2.

TMDL Reach 63 new and carryover pounds of phosphorus reductions by year.

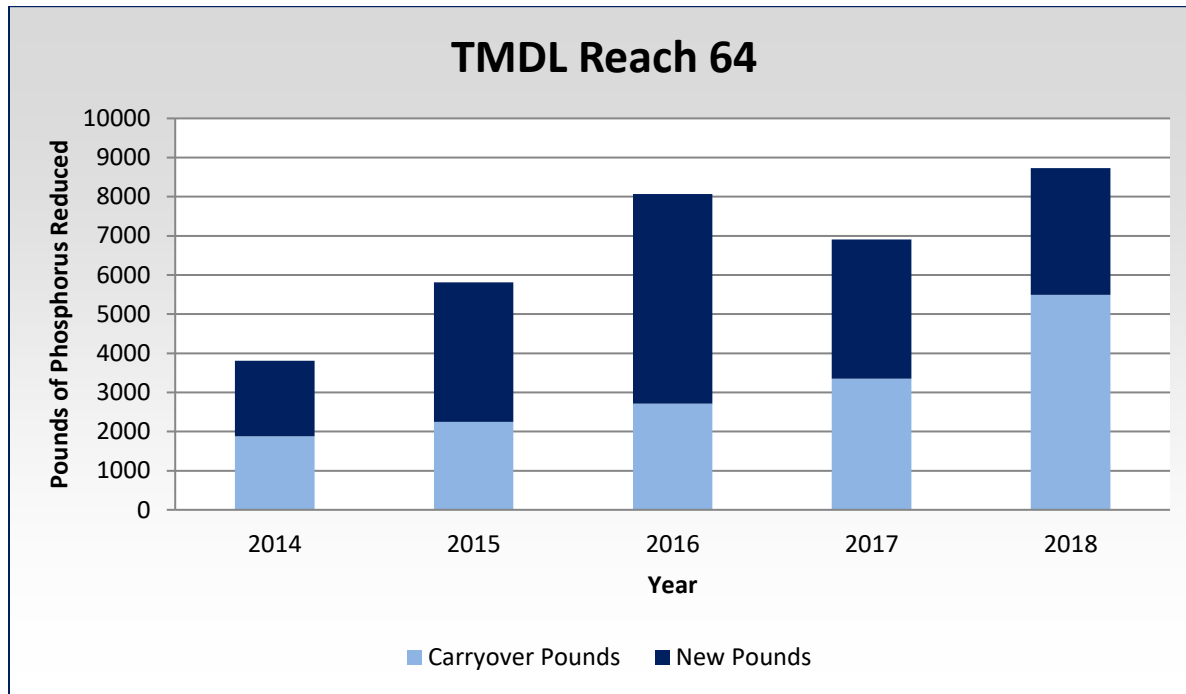
FIGURE 11.3.

TMDL Reach 64 new and carryover pounds of phosphorus reductions by year.

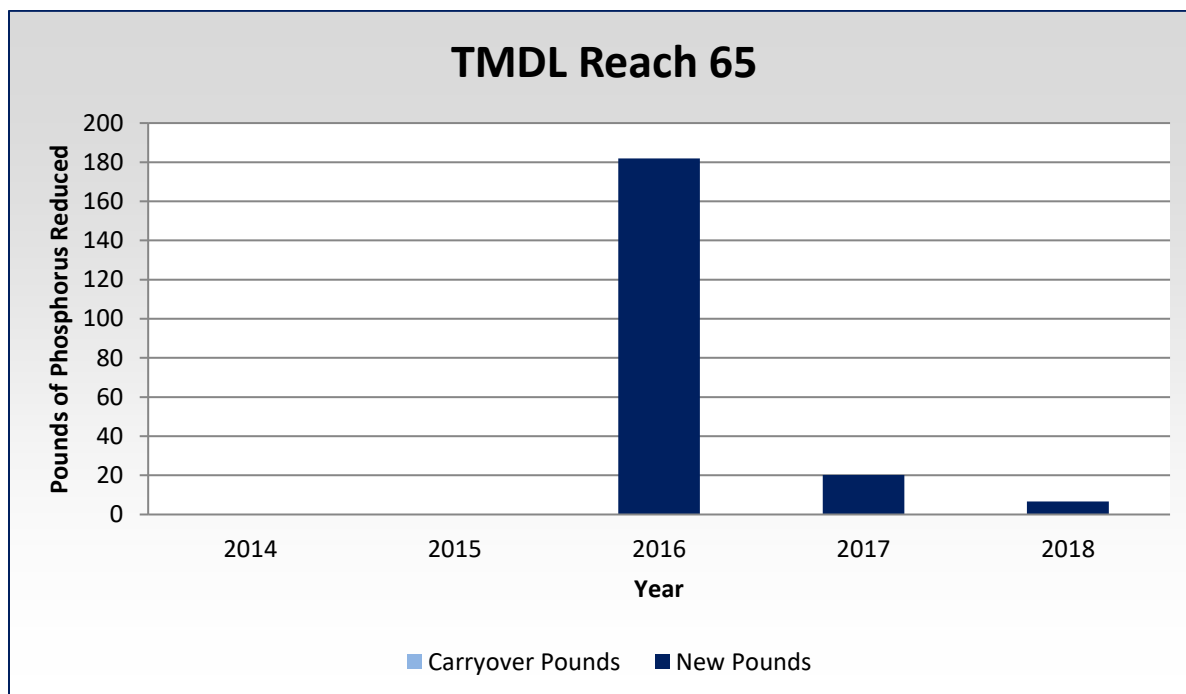
FIGURE 11.4.

TMDL Reach 65 new and carryover pounds of phosphorus reductions by year.

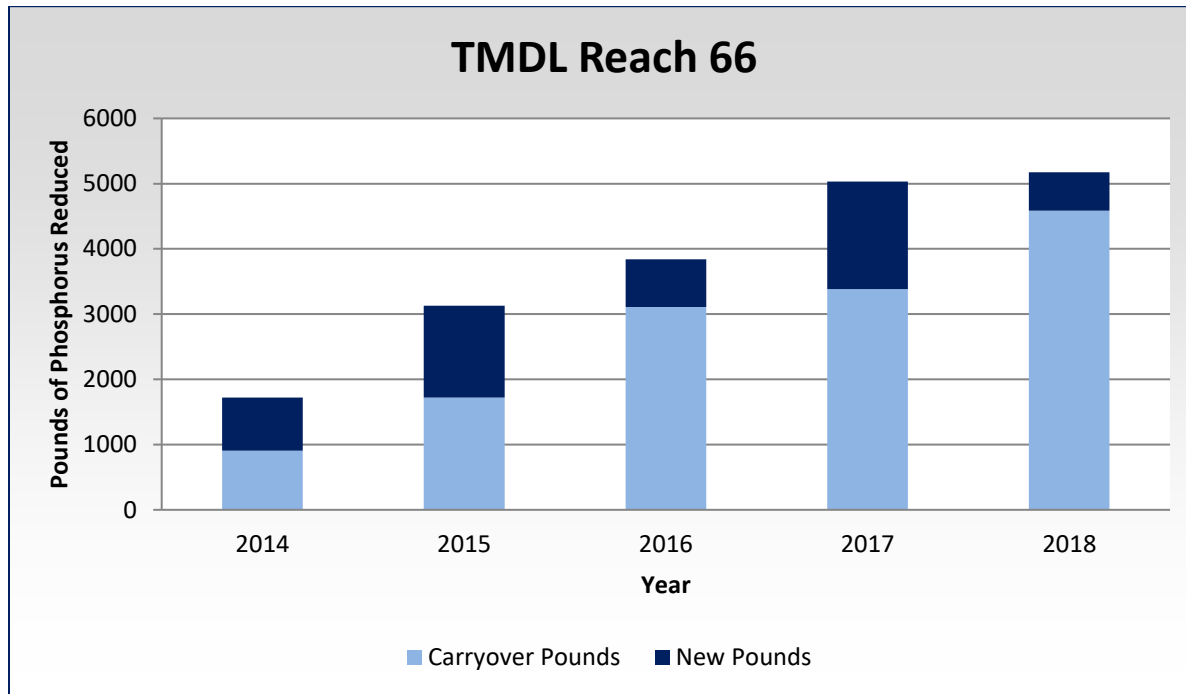
FIGURE 11.5.

TMDL Reach 66 new and carryover pounds of phosphorus reductions by year.

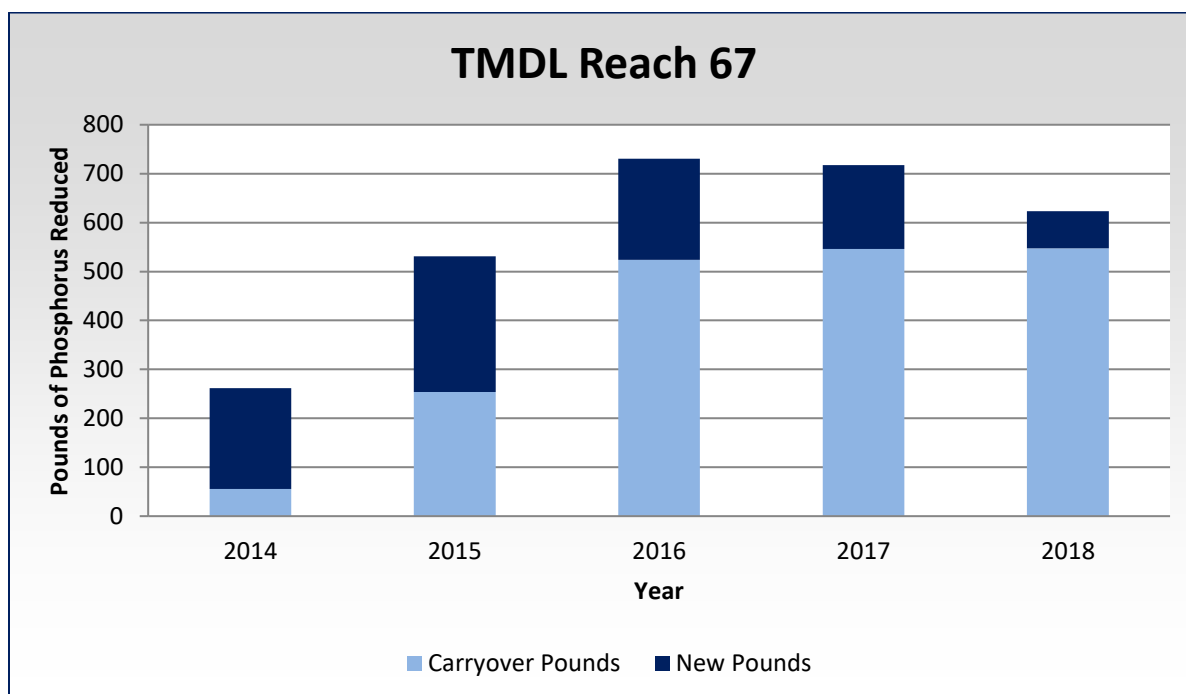
FIGURE 11.6.

TMDL Reach 67 new and carryover pounds of phosphorus reductions by year.

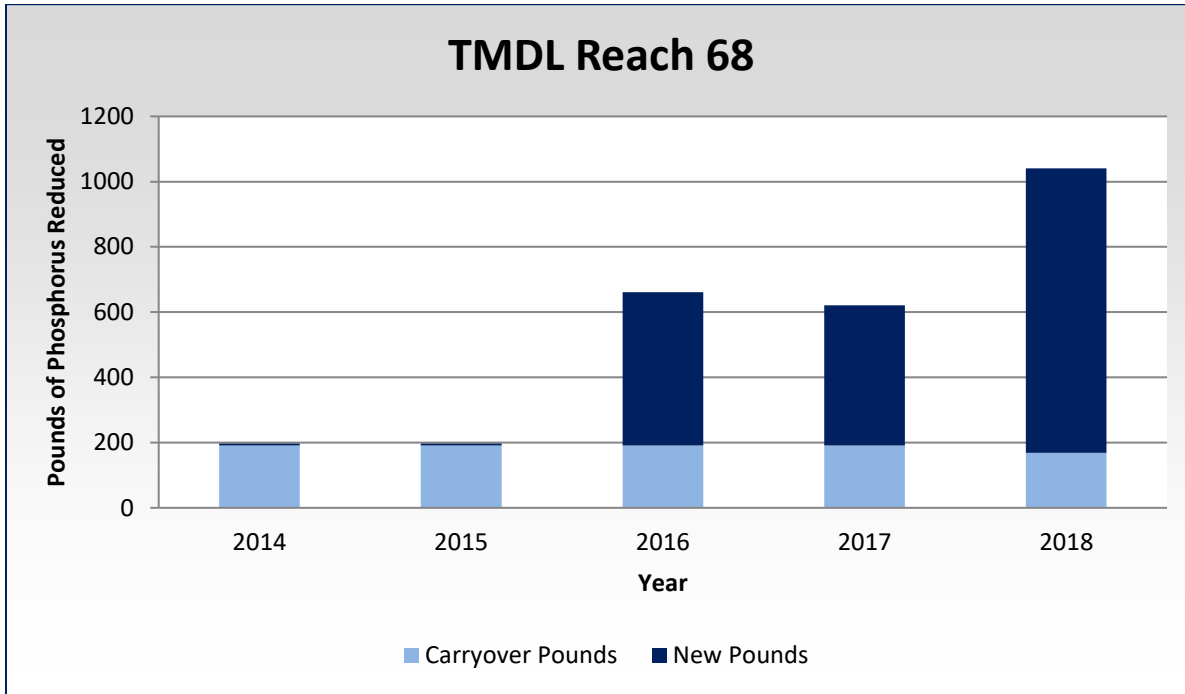
FIGURE 11.7.

TMDL Reach 68 new and carryover pounds of phosphorus reductions by year.

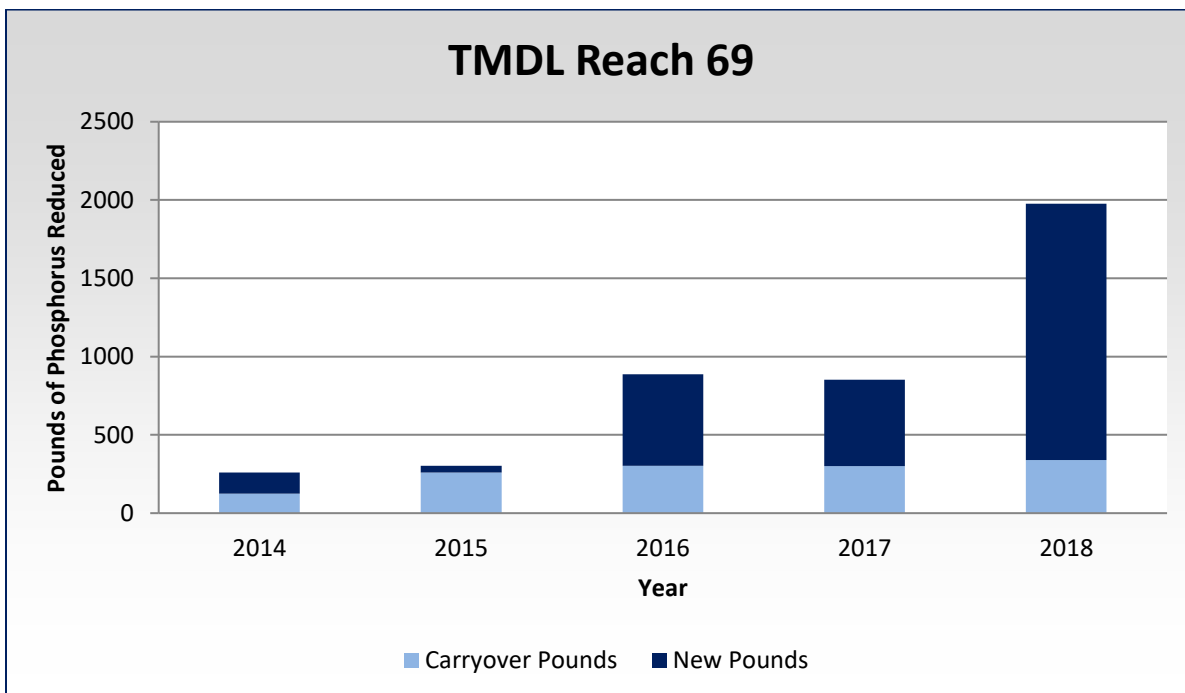
FIGURE 11.8.

TMDL Reach 69 new and carryover pounds of phosphorus reductions by year.
