# Annual Dane County Yahara WINS Adaptive Management Report

Annual report on Dane County Land & Water Resources Department efforts assisting with the implementation of conservation practices that reduce phosphorus runoff for the Yahara WINS Adaptive Management project.

## 2019 Report Year

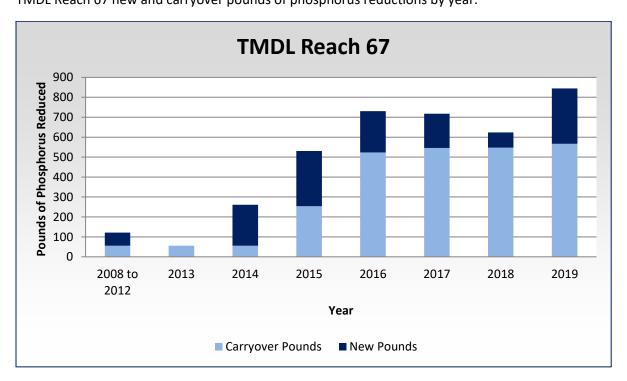
FIGURE 11.6.

TMDL Reach 67 new and carryover pounds of phosphorus reductions by year.
