# Annual Dane County Yahara WINS Adaptive Management Report

Annual report on Dane County Land & Water Resources Department efforts assisting with the implementation of conservation practices that reduce phosphorus runoff for the Yahara WINS Adaptive Management project.

## 2023 Report Year

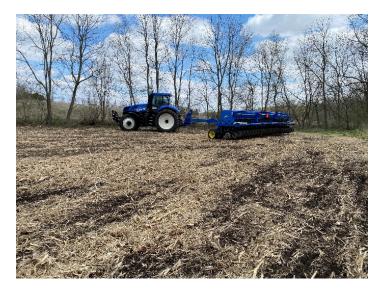
Left: CCP Field being no-till planted to pasture Right: Newly established prairie

Dane County's Continuous Cover Program, launched in 2019, continues to be a popular program. This program provides cost-share assistance to landowners for the establishment and maintenance of a continuous living cover on lands that are traditionally row-cropped. Landowners can convert row cropped fields to cool season grasses, prairie and pollinator habitat, or forage for managed grazing. The option to incorporate trees into plantings, such as agroforestry or silvaculture, was added to the program in 2023. More information on the program can be found here: <a href="https://lcd-lwrd.countyofdane.com/Continuous-Cover-Program">https://lcd-lwrd.countyofdane.com/Continuous-Cover-Program</a>

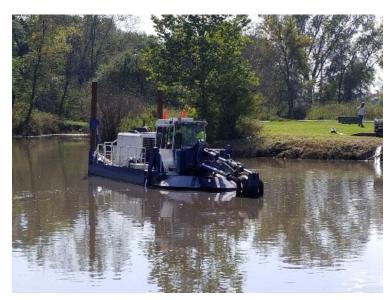
Hydraulic dredge removing legacy sediments from Token Creek.

Since 2016, Dane County has been assessing and removing legacy sediments within stream tributaries of the Yahara Watershed. Dorn Creek, Sixmile Creek, Token Creek, Door Creek, Nine Springs Creek, and the Yahara River have all been sampled and assessed for both phosphorus concentrations and sediment volumes. Sediments have been removed from three sites; Dorn, Sixmile and Token Creeks.
