Wisconsin Department of Natural Resources Water Resources South District

Yahara Watershed Improvement Network (WINS) Adaptive Management Project

2017-2019 Status Report

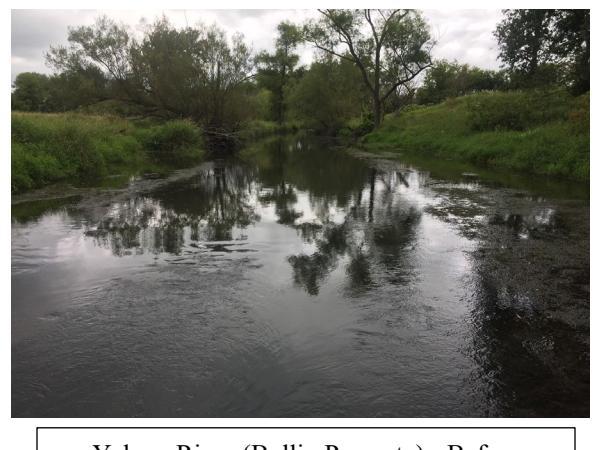
Yahara River (Bollig Property) - Before

At the STH 19 (Bollig property), biologists were somewhat puzzled by the lack of

numbers and variety of fish found in this section in 2017, particularly given the amount of fish cover. There was an increase in numbers of fish and species diversity in the 2018 survey. The reason for this cannot be explained as the habitat metrics were almost identical pre- and postcrossing removal. Because of the natural stream narrowing which occurred, it was assumed there would be increased velocity, resulting in a decrease in fine sediments. Based on measurements taken, this did not occur. While the area experienced some high flows, the gradient of this stretch is not particularly high and may require more time for sediment mobilization.

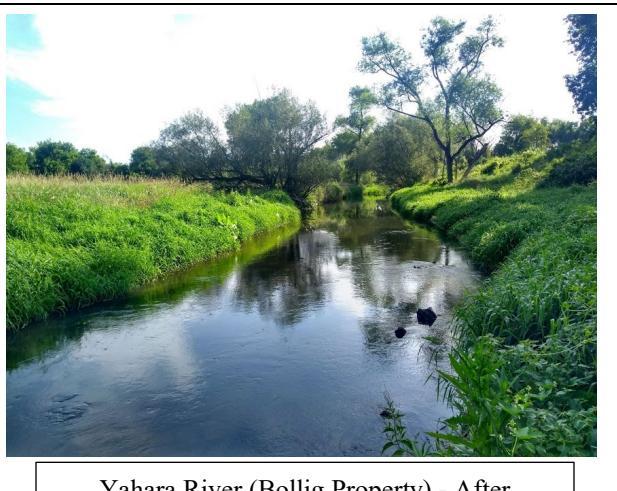
Yahara River (Bollig Property) - After

Macroinvertebrate quality did not change pre- and post- crossing removal. This is not surprising as the macroinvertebrates are more indicative of water quality. The MIBI score was "fair" and similar to the score at Windsor Road. The HBI was "fair" indicating some organic loading.
