Annual Dane County Yahara WINS Adaptive Management Report

Annual report on Dane County Land & Water Resources Department efforts assisting with the implementation of conservation practices that reduce phosphorus runoff for the Yahara WINS Adaptive Management project.

2024 Report Year

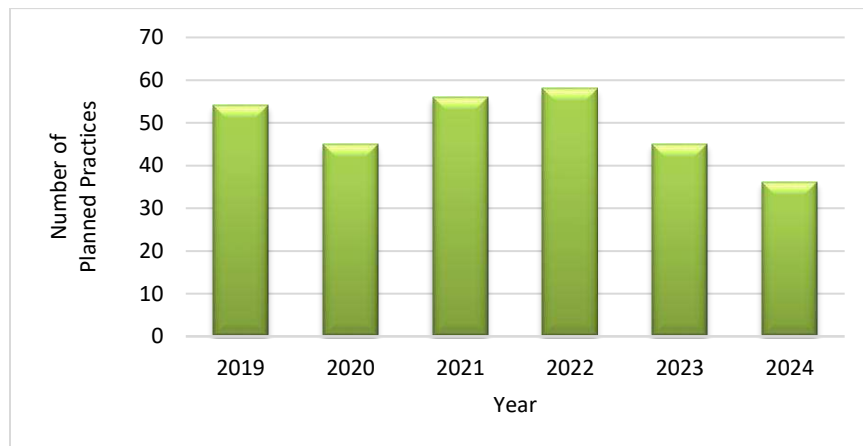
Figure 1. Number of planned conservation practices within the Yahara watershed identified in the Dane County annual work plan.

At the beginning of 2024, 36 conservation practices were identified (Figure 1) where Dane County LWRD staff would provide planning assistance. Many of these planned practices were voluntarily implemented by landowners and, throughout the year, additional conservation practices were designed and implemented.

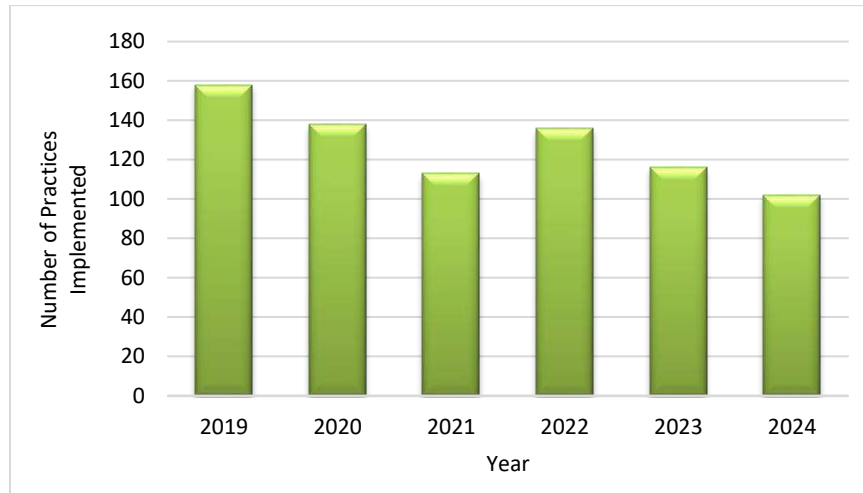
Figure 2. Number of conservation practices implemented within the Yahara watershed.

Over the last year, 102 conservation practices were implemented (Figure 2 and Figure 3) effectively reducing the amount of phosphorus that reaches nearby surface waters from runoff. The number of newly implemented practices reduced from previous years. However, this aligns with an overall reduction in funding (Figure 5 and Figure 6).

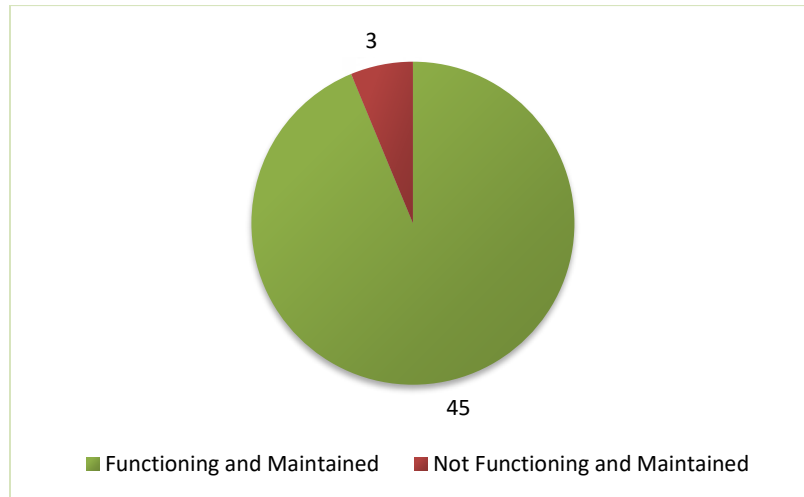
Figure 4. Field verification and review of conservation practices.

Dane County LWRD staff inspected all of the 48 conservation practices that were identified for verification this past year. All of the inspected practices were located in TMDL reaches 63 and 64. From the inspections, 45 (94%) practices were found to be functioning and maintained, while 3 (6%) practices were not functioning (Figure 4). Reasons for these practices no longer functioning and being maintained include the conversion of land from agriculture to residential use or conservation practices requiring repairs and maintenance.

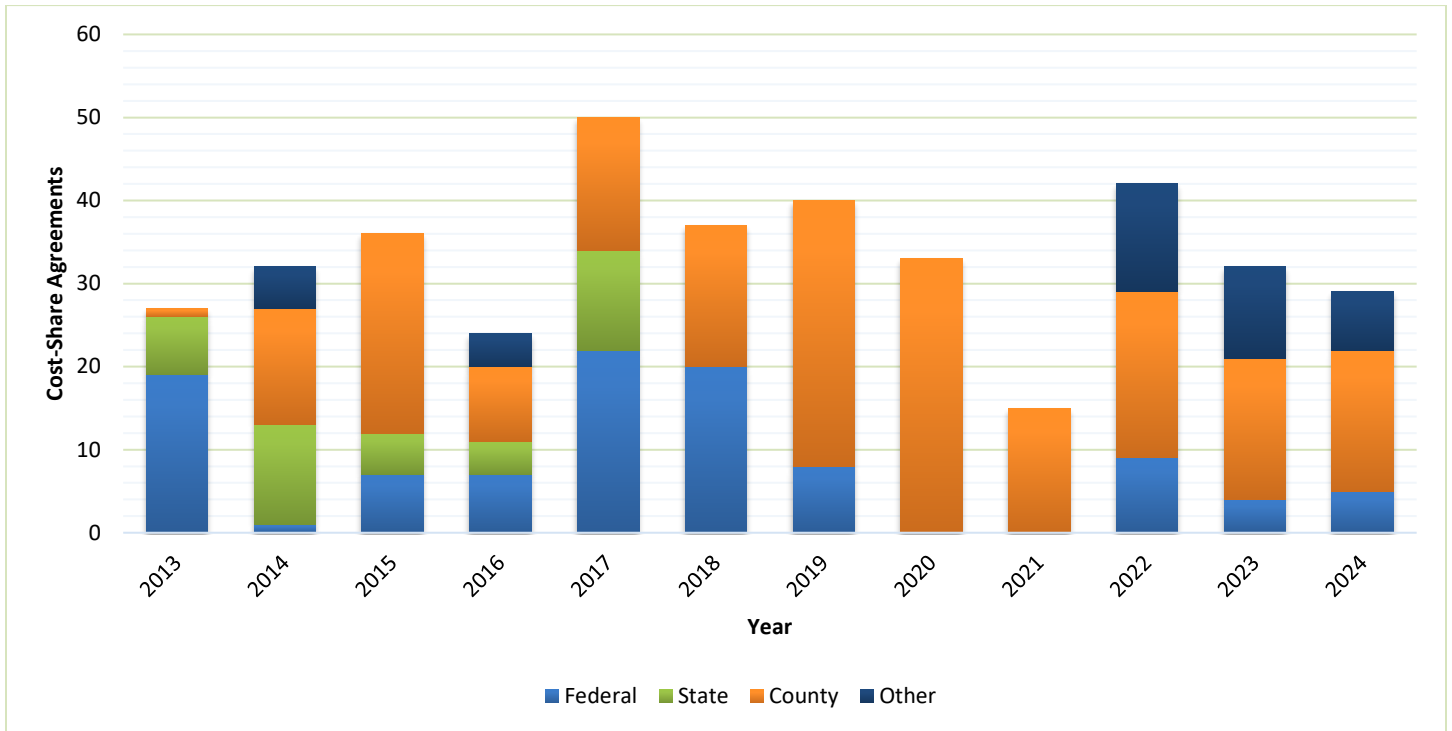
Figure 5. Number of cost-share agreements by funding source.

Dane County LWRD assisted with 29 new cost-share agreements with landowners, utilizing federal, county, and other funding sources (Figure 5) within the Yahara watershed. The total cost-share funding for these agreements was over \$368,378 (Figure 6). Since 2013, Dane County has assisted with over \$8 million in cost-share agreements for conservation practices aimed at reducing phosphorus in the watershed. Dane County strives to utilize and leverage all funding sources available including federal, county, and other sources (i.e. Yahara WINS, Clean Lakes Alliance grants, etc.) to support landowners and producers with conservation practices. The available funds and conditions vary annually by funding source and the number of agreements are dependent on the interest from landowners and producers for implementing conservation practices.

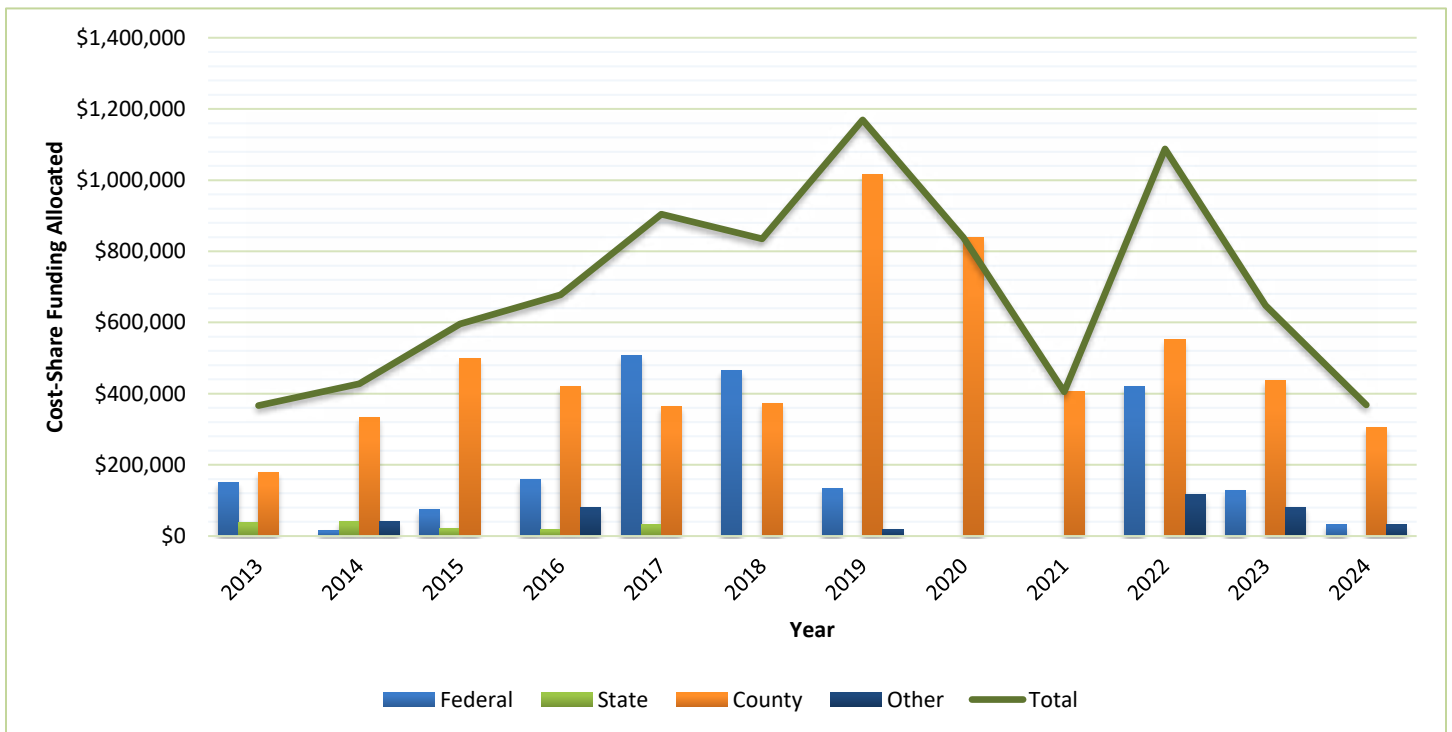
Figure 6. Total cost-share dollars allocated by funding source annually within the Yahara watershed.

Under the current Service Agreement, Yahara WINS provides Dane County with \$540,000 for assisting with implementing conservation practices and the WINS Adaptive Management project. In 2024, \$157,770 was used in providing cost share assistance, directly to landowners and individuals, to aid in implementing phosphorus reducing conservation practices. The remaining, approximately, \$382,000 was used to partially fund staff and equipment required to plan, design, implement, document, verify, and map the conservation practices and nutrient management plans that were reported to Yahara WINS.

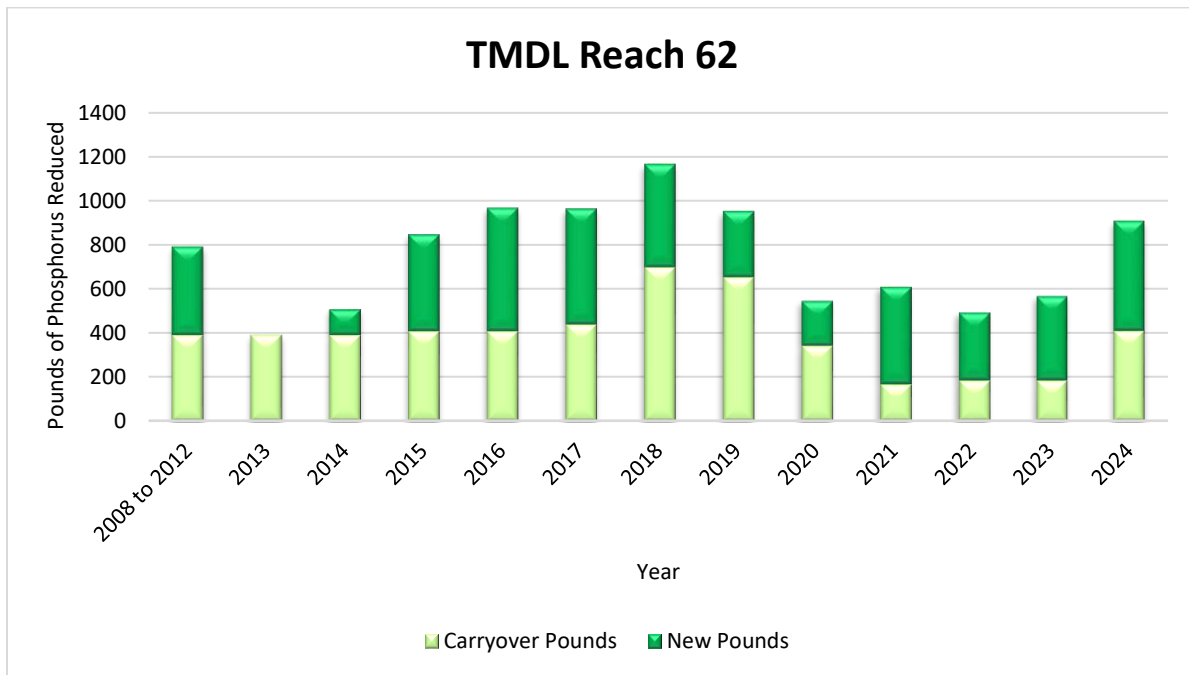
Figure 8. TMDL Reach 62 new and carryover pounds of phosphorus reductions by year.

Table 1 and Figure 8-Figure 15 (in the appendix) illustrate these reductions of phosphorus over time in the Yahara watershed and the corresponding TMDL reaches.

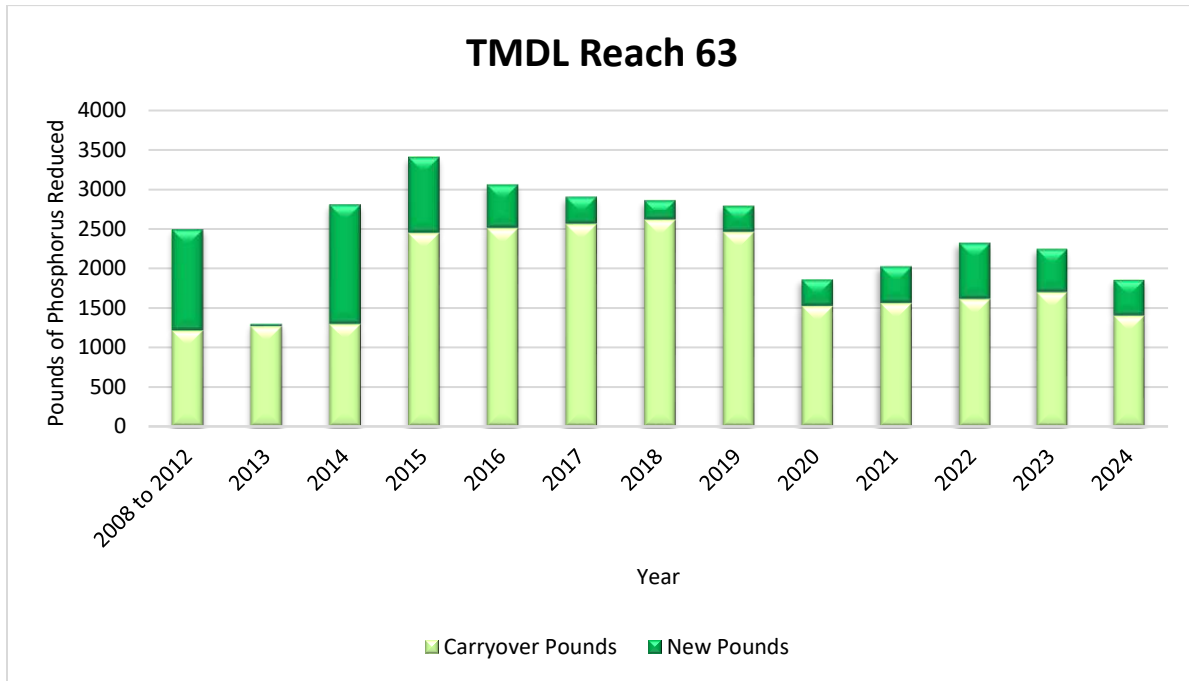
Figure 9. TMDL Reach 63 new and carryover pounds of phosphorus reductions by year.

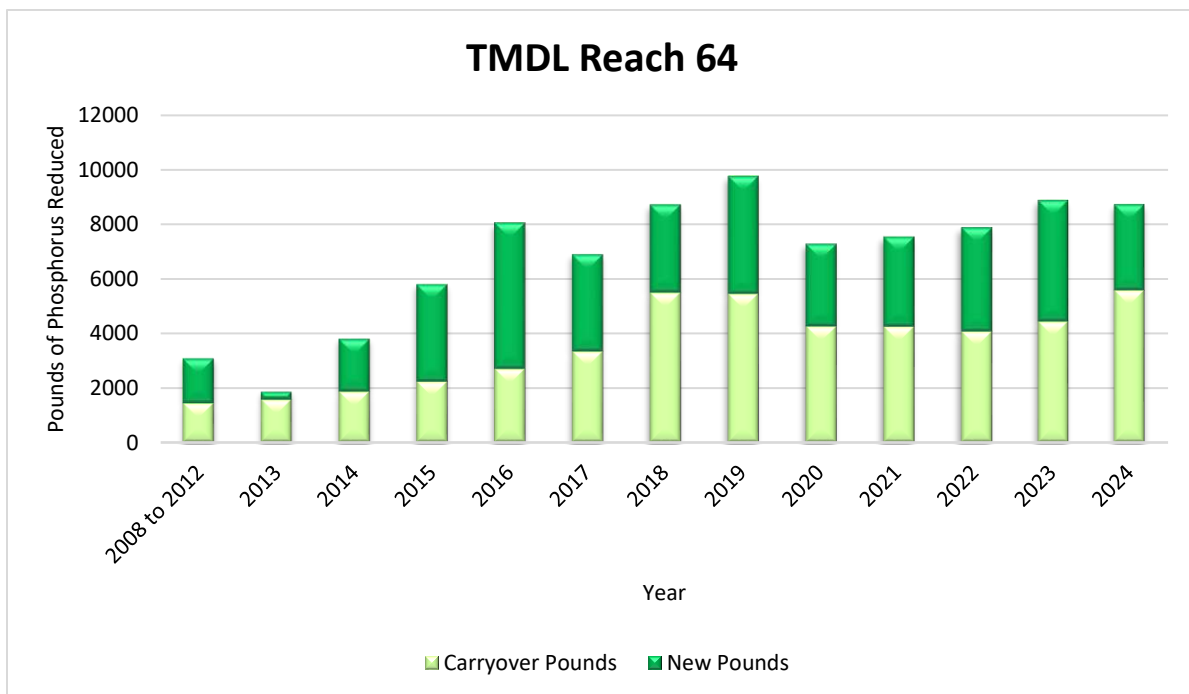
Figure 10. TMDL Reach 64 new and carryover pounds of phosphorus reductions by year.

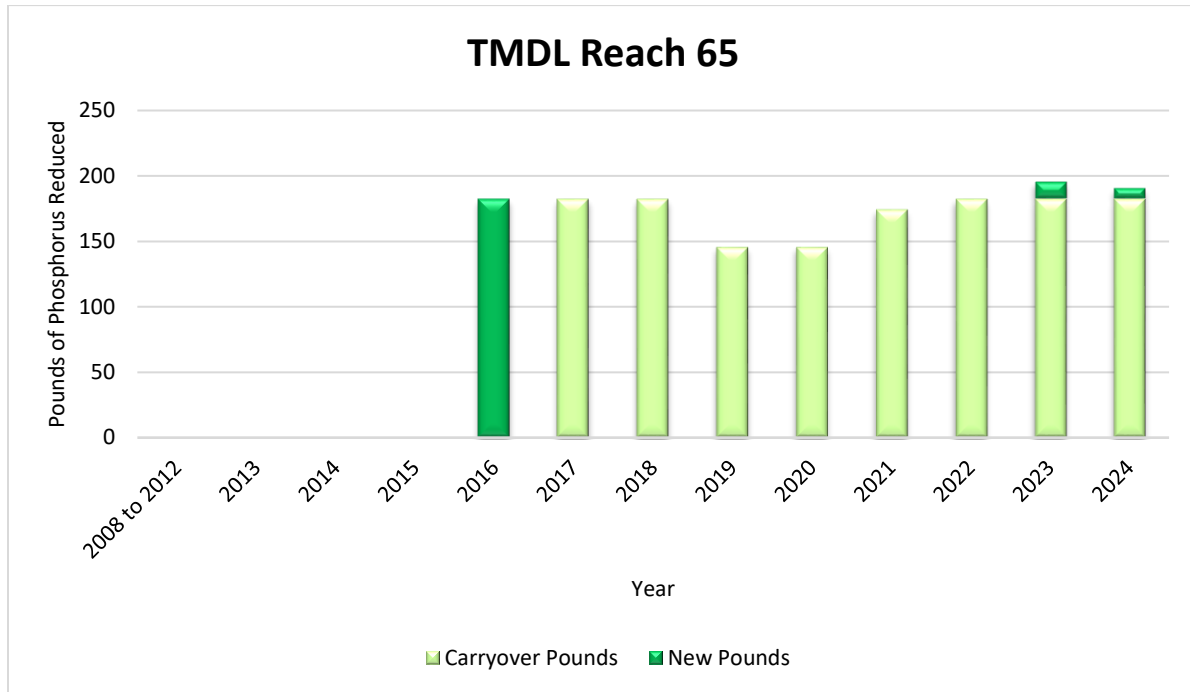
Figure 11. TMDL Reach 65 new and carryover pounds of phosphorus reductions by year.

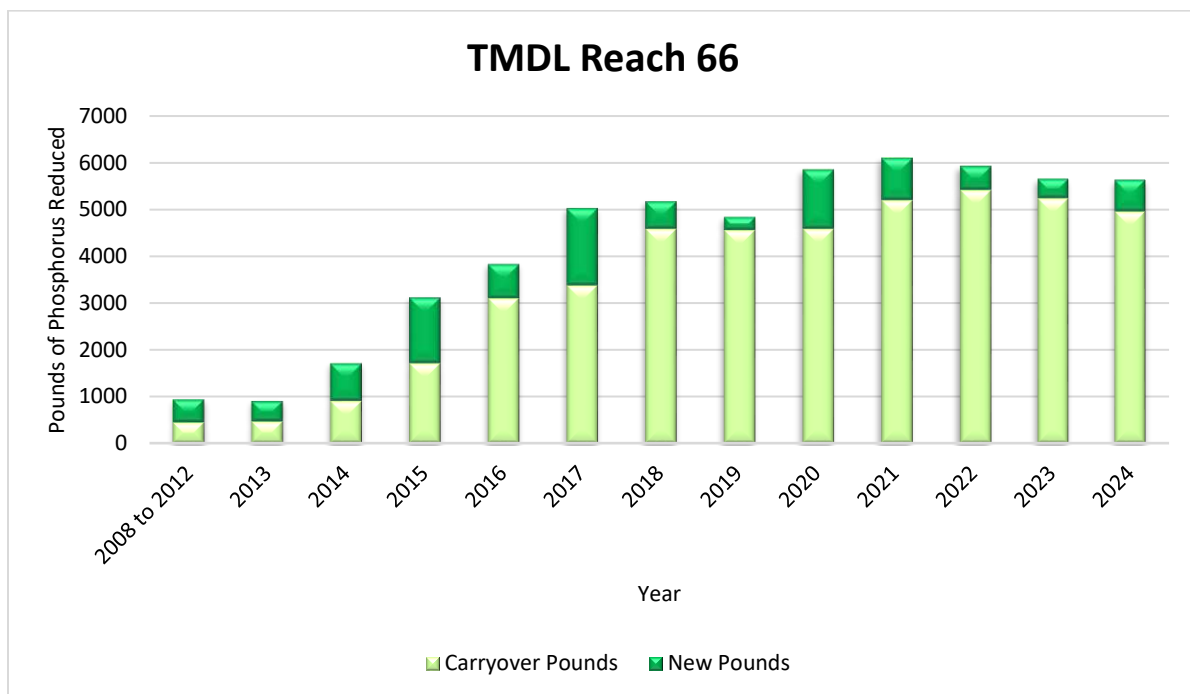
Figure 12. TMDL Reach 66 new and carryover pounds of phosphorus reductions by year.

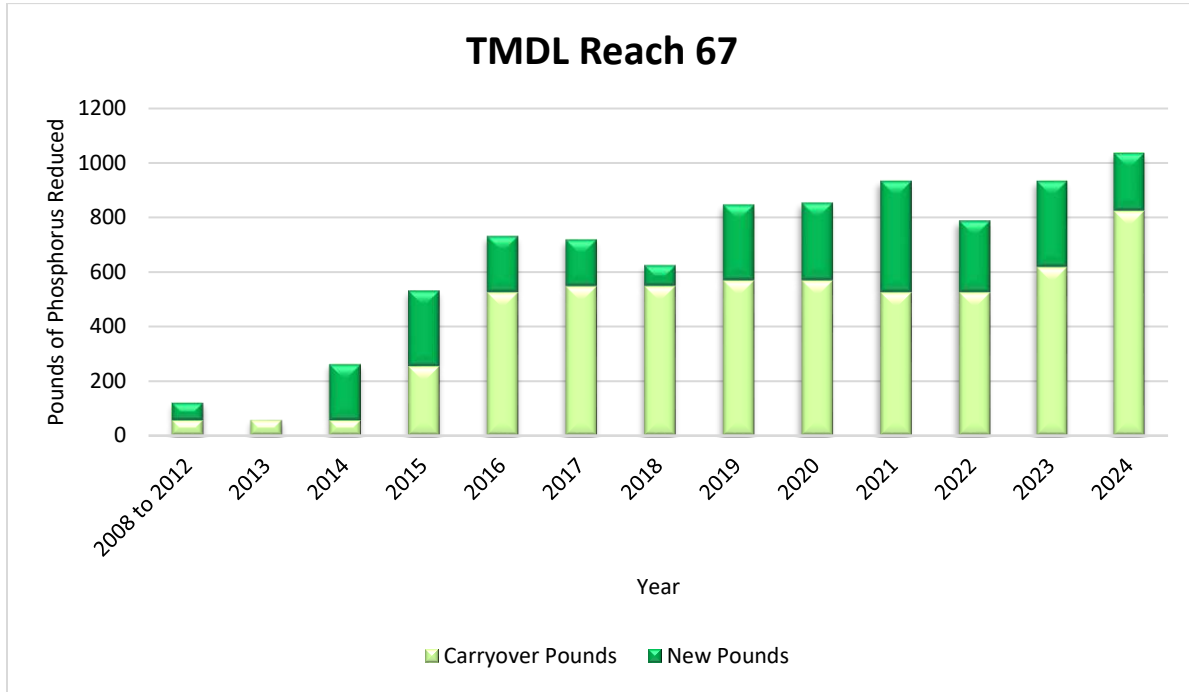
Figure 13. TMDL Reach 67 new and carryover pounds of phosphorus reductions by year.

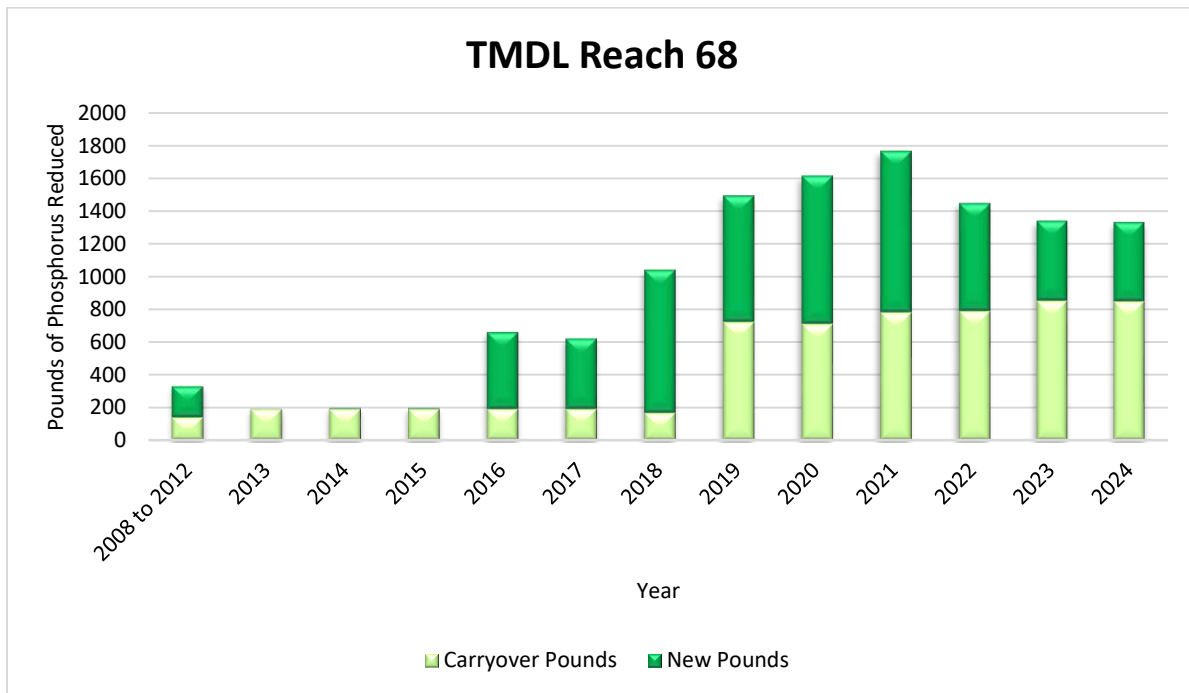
Figure 14. TMDL Reach 68 new and carryover pounds of phosphorus reductions by year.

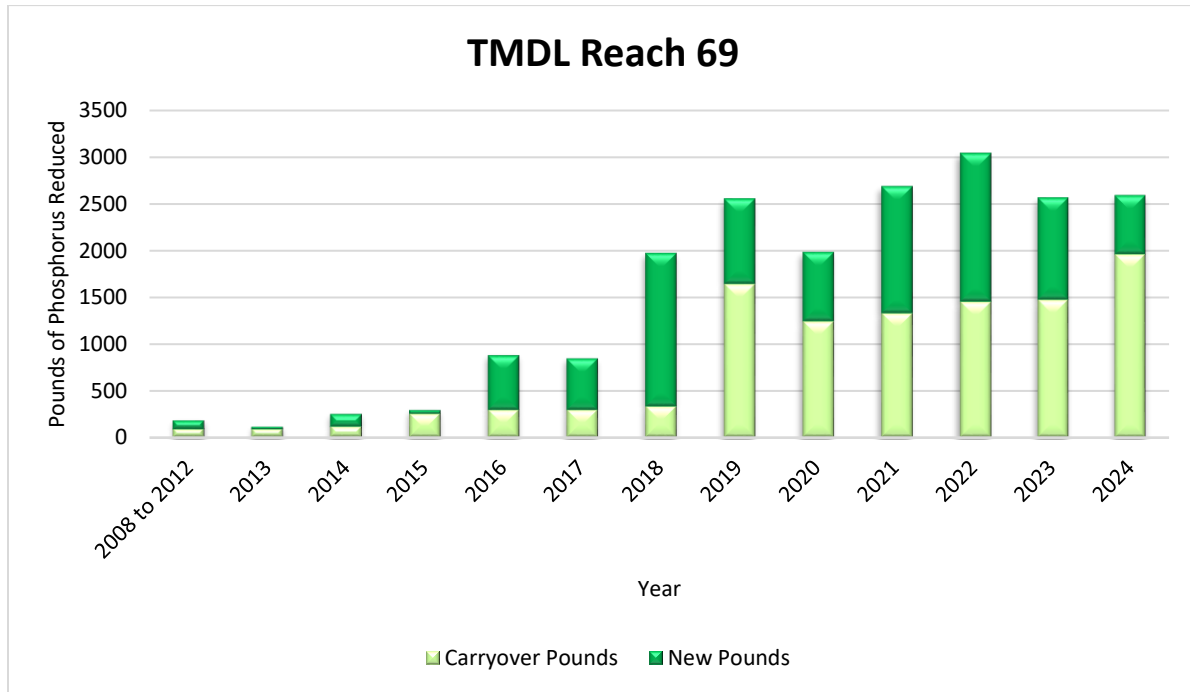
Figure 15. TMDL Reach 69 new and carryover pounds of phosphorus reductions by year.
